RAILROAD ACCIDENT INVESTIGATION

Report No. 4123

CHICAGO, SOUTH SHORE AND SOUTH BEND RAILROAD

APRIL 14, 1967

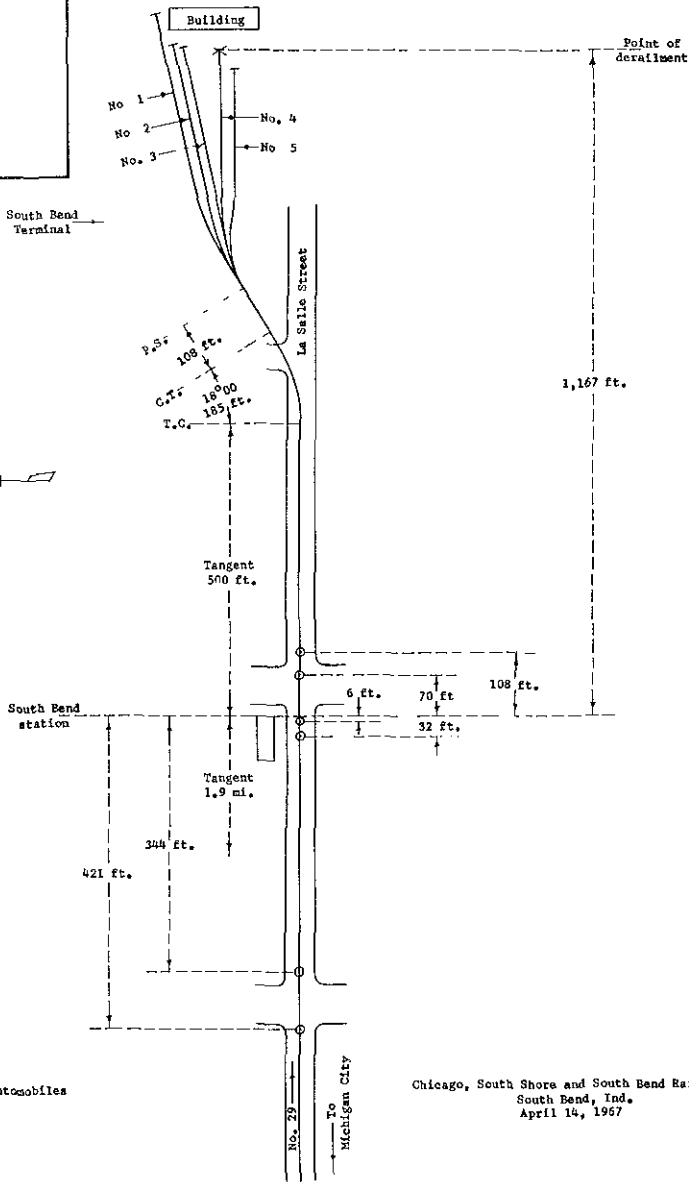
The collisions occurred on LaSalle Street, 421, 344, 32 and 6 feet west, and 70 and 108 feet east, of the east end of the South Bend station. The derailment occurred at South Bend Terminal, at the east end of stub yard track No. 4 and 1,167 feet east of the South Bend station.

© Points where automobiles were struck.
