NATIONAL
TRANSPORTATION
SAFETY
BOARD

RAILROAD ACCIDENT REPORT

COLLISION BETWEEN NORTHERN INDIANA
COMMUTER TRANSPORTATION DISTRICT
EASTBOUND TRAIN 7 AND WESTBOUND TRAIN 12
NEAR GARY, INDIANA, ON JANUARY 18, 1993

ADOPTED: December 7, 1993

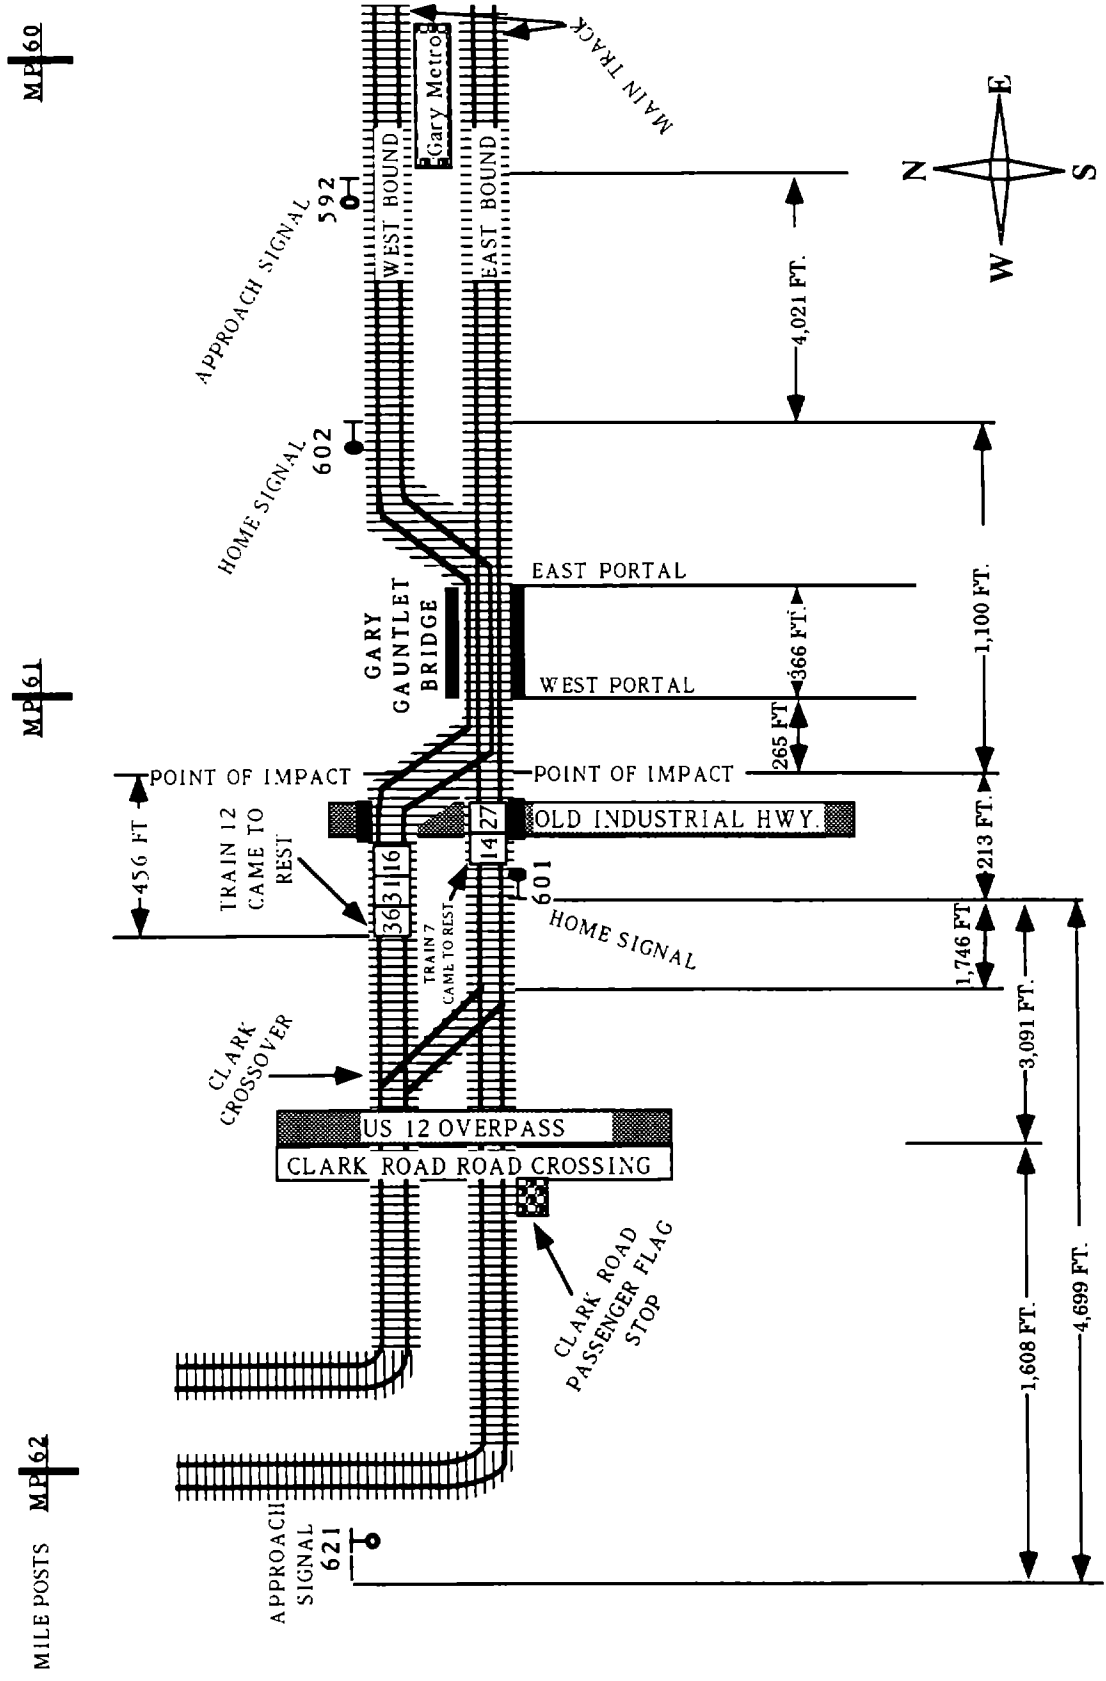
Figure 2.--Postaccident track diagram.

The engineer of train 7 continued by saying that he recalled when the signal looked "dark," he then stood up to have a better view and saw the signal was "red." He added that the train was about 212 feet west of the signal when he saw it as "red" and that he immediately placed the train brakes in emergency application. Train 7 came to rest about 213 feet east of signal 601 and encroached the westbound track by 1 foot. (See figure 2.) The engineer said that once train 7 came to "rest," he could see train 12 on the bridge. This train collided with train 7, which pushed train 7 westward about 12 feet from the point of impact.

At Ogden Dunes, Indiana, a deadheading⁶ collector/brakeman, who was also qualified as an engineer, boarded train 12 and entered the control compartment. (The normal NICTD practice is for the engineer to be alone in the control compartment while operating the train.) Both he and the engineer said that they called signals en route as prescribed by the NICTD rules⁷ and noted that before the Gary Gauntlet Bridge, both signals 592 and 602, which governed the train over the bridge, displayed a proceed indication. They saw train 7 approaching, as train 12 was then on the bridge, from the west. As train 12 crossed and exited the bridge, the engineer and collector/brakeman saw that train 7 had passed signal 601. When the collector/brakeman saw train 7 was in the path of train 12, he left the control compartment, entered the passenger compartment, and dove onto a row of seats. The engineer stated that he put train 12 into emergency braking as the collector/brakeman left the control compartment. The engineer control stand is in the right corner of the control compartment. The left front corner of the train 12 lead car struck the left front corner of the train 7 lead car. Train 12 came to rest 456 feet west of its point of impact with train 7.

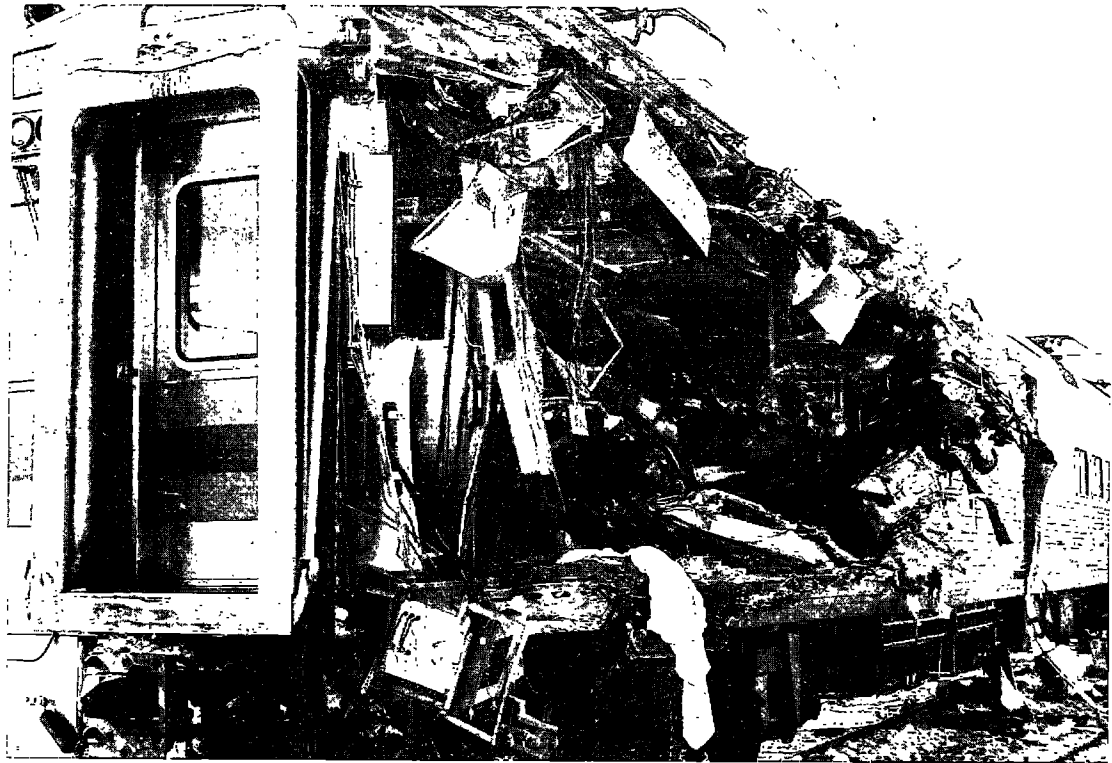
a.--Car 27 on train 7.

Train 7 Collision Damage -- Impact damage was concentrated to the left front corner on lead car 27 of train 7. (See figure 4a.) The entire left front corner post structure, which included the door structure and the front of the car, was missing from floor to roof. The car body sidewall separation extended about 27 feet.

An interior inspection of car 27 revealed a wall of impact debris near the sidewall separation; however, virtually no damage or debris was at the opposite end of the car. A single, large segment of car body wall had intruded and rotated into the car, and it was wedged at 90 degrees to its initial orientation across the compartment against the opposite wall. Jagged pieces of sheet metal, broken seats, and related impact debris were strewn about the area. Inspection of several damaged seats revealed that their seatbacks and legs were bent in the opposite direction to their normal mounted position and were torn from their floor mountings.

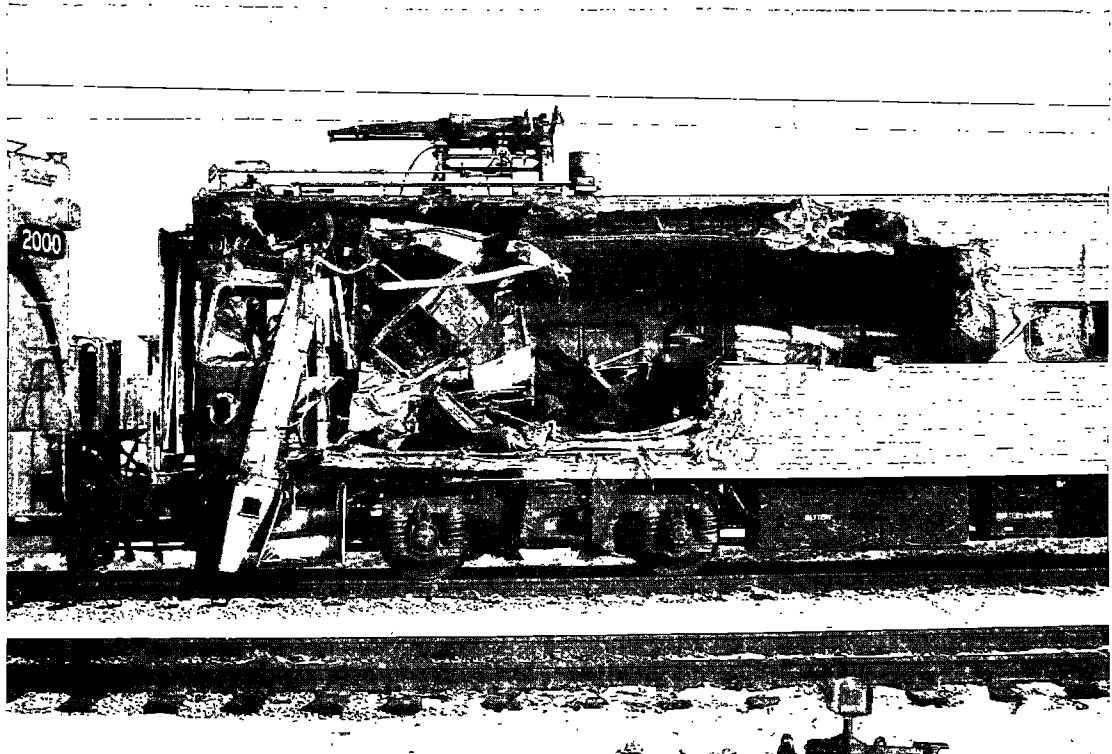
b.--Car 36 on train 12.

Train 12 Collision Damage -- Impact damage was concentrated to the left front corner on lead car 36 on train 12. (See figure 4b.) An external inspection of the car body side structure revealed a major separation from the left corner of the front end, extending along the left side, to and including the third window; this separation extended about 27 feet. The front left corner post structure was displaced about 1 foot inward and about 2 feet rearward from floor to roof. The door frame structure adjacent to the left front corner post appeared structurally unaffected by the impact. Significant dents, gouges, and gashes were visible in the sheet metal panel structure. A vertical indentation was on the left front panel of the car, outboard of the headlight. This indentation was about a foot from the extreme corner edge and extended from the lower frame of the left front window down to the car floor.

The car body sidewall structure from the floor to the roof, including the left front door and door pocket, was missing. The car body sidewall had separated at this point, and a jagged edge was visible along the floorline and the roofline of the separation. Inspection of several damaged seats revealed that their seatbacks and legs were bent in the opposite direction to their normal mounted position and were torn from their floor mountings. Seats, bent almost flat to a fully collapsed condition, were stacked upon the adjacent seats in a fallen-domino configuration. Impact scratches and gouges were visible on the ceiling and interior car body wall opposite the separation.

A single segment of sidewall that consisted of an intact, although visibly damaged, window and related window/sidewall framing intruded into the car. Attached to the car body wall, it was suspended about 5 feet from the floor in a horizontal orientation, pointing in a rear direction. The tube frame of the luggage rack was dented at a point opposite its attachment to the car body wall.

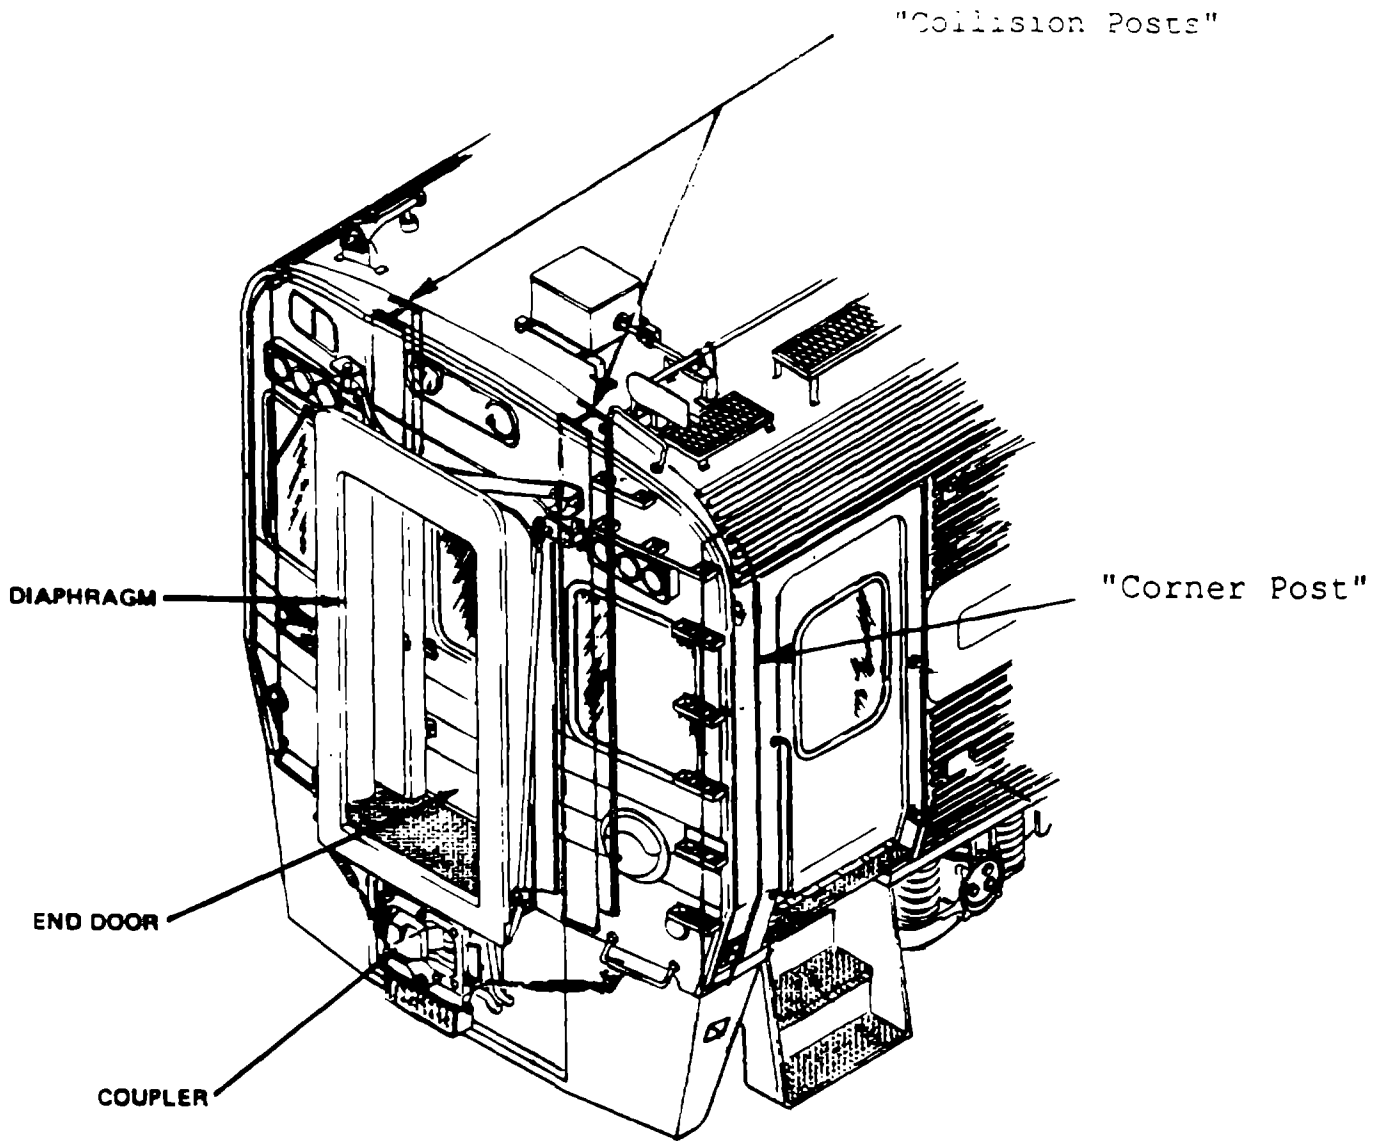
Figure 5.--Diagram showing position of collision posts and corner post on passenger rail car.

"structural post" refers to a structural element that attaches the end bulkhead (partition) to the end door and should not be confused with a structural corner post that is designed specifically for collision energy absorption and to resist car body intrusion in the corner areas.

As noted above, the design requirements in 49 CFR 229.141 do not address car body corner post structural requirements. Because this accident was the second collision within a 2-year period to involve corner-to-corner impact and it resulted in numerous fatalities and serious injuries that may have been prevented, the corner post design requirements of MU locomotives have become a significant crashworthiness issue of particular interest to the Safety Board. MU locomotive passenger cars that are built without adequate collision energy absorption structures in the corner post assemblies are vulnerable to car body intrusion in noncoupler-to-coupler collisions. The use of an energy absorption structure in the corner post assembly, similar to the collision post that is required on each side of the control compartment door, would have provided significant additional resistance to impact intrusion.

The damage that both trains sustained after the initial impact resulted from the action of dynamic forces that caused the left front corner and sidewall of the passenger compartment of each car to experience a complete structural failure and intrude inward. Because no structure was available in the corner post areas to successfully absorb the crash forces of the collision, the substantial car body intrusion into each car left no survival space in the left front areas of either car. Consequently, the collision produced numerous fatalities and serious injuries. The Safety Board concludes that the use of collision energy absorption structures in the corner post assemblies of these rail cars would have decreased the impact intrusion in this collision and may have prevented or substantially reduced the number of fatalities and serious injuries.
