NATIONAL
TRANSPORTATION
SAFETY
BOARD

RAILROAD ACCIDENT REPORT

COLLISION BETWEEN NORTHERN INDIANA
COMMUTER TRANSPORTATION DISTRICT
EASTBOUND TRAIN 7 AND WESTBOUND TRAIN 12
NEAR GARY, INDIANA, ON JANUARY 18, 1993

ADOPTED: December 7, 1993

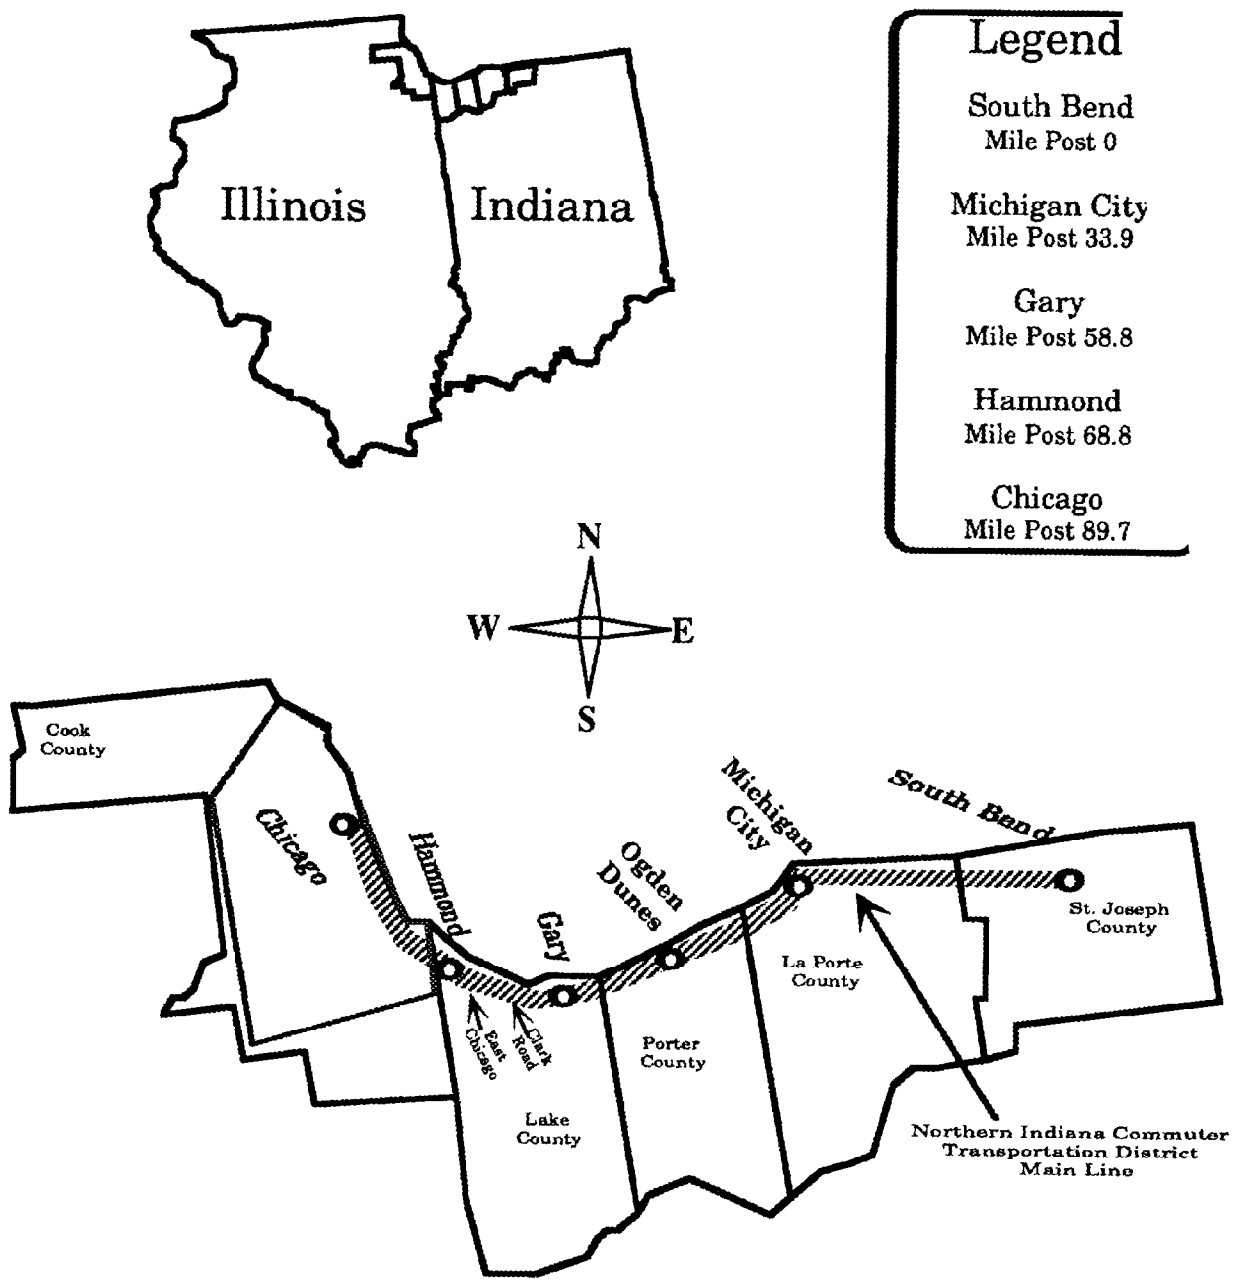
Figure 1.--Commuter train route between South Bend, Indiana, and Chicago, Illinois.

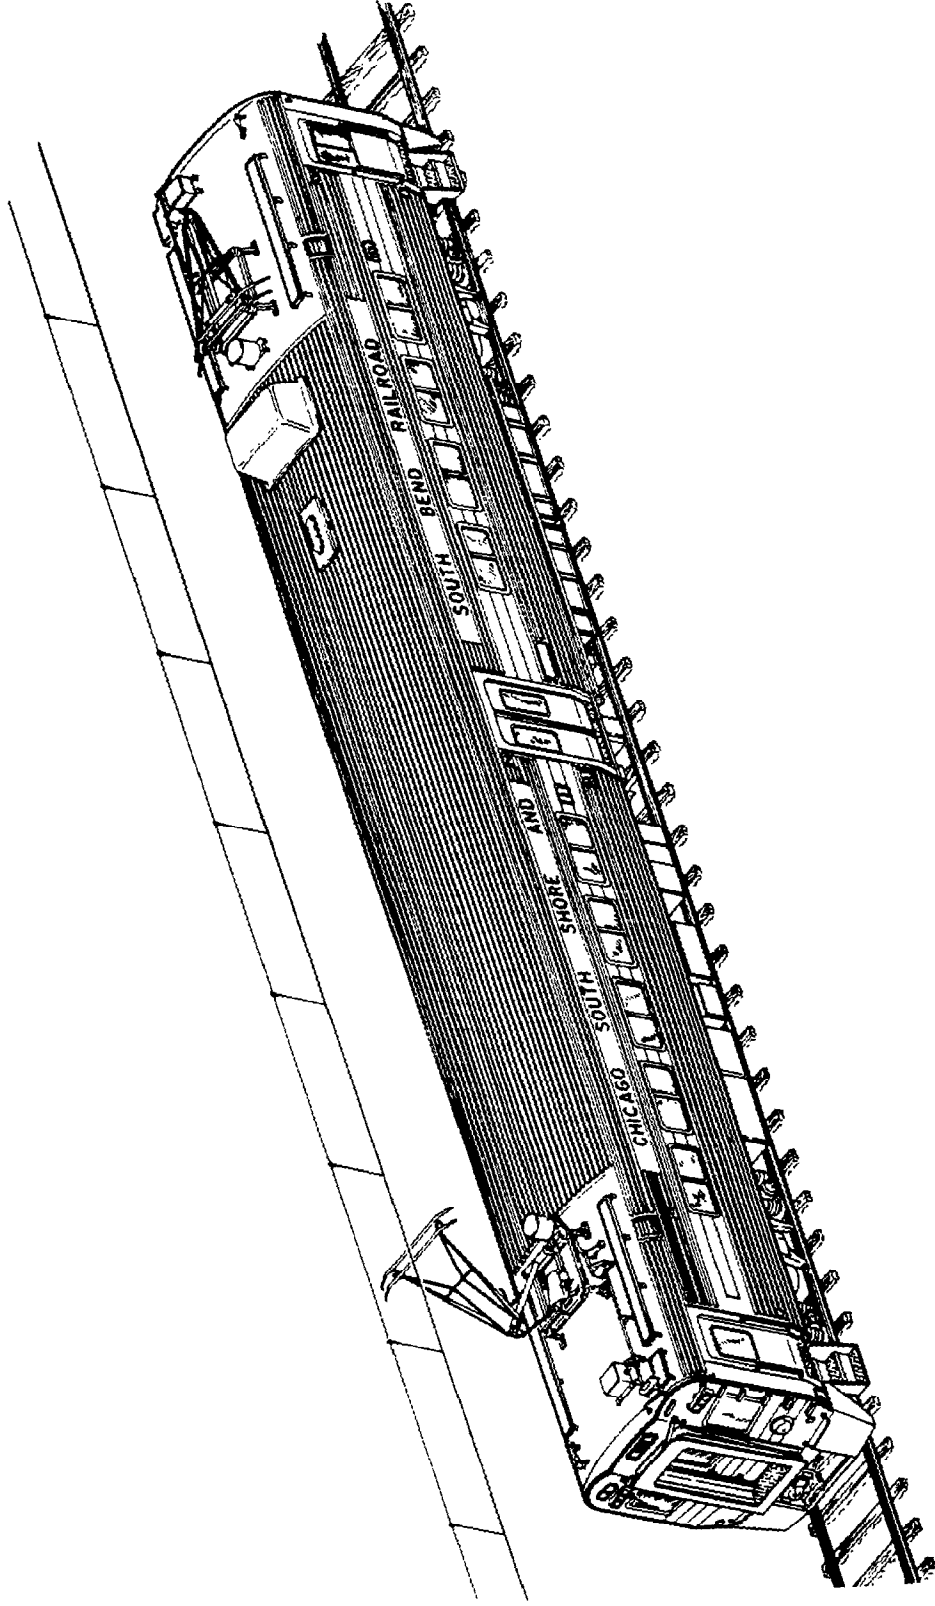
The self-propelled, MU, electric-powered, light-weight stainless steel construction, passenger rail cars¹⁴ that the NICTD operates in revenue service (see figure 3) are typical of the self-propelled electric cars used in suburban commuter rail service. Each 85-foot-long, 118,000-pound car operates on 1,500 volts, direct current, supplied by overhead catenary wire. The operator controls are in a control compartment at both ends of each car. The NICTD operates its trains in consists of up to eight cars; however, the operator controls at both ends allow individual unit operation. Each car has a 93-passenger seating capacity and is generally fitted with bench seats that accommodate 2 passengers each. The benches are mounted so that the seated passengers face the middle of the car.

Figure 3.--Exterior view of NICTD electric passenger railroad car.
Source: *NICTD Running Maintenance and Trouble Shooting Manual*, September 1982.
