REPORT NO. 3567
ILLINOIS CENTRAL RAILROAD COMPANY
IN RE ACCIDENT
AT VAN BUREN STREET,
CHICAGO, ILL., ON
APRIL 25, 1954

Accident at Van Buren Street, Chicago, Ill., on
April 25, 1954, caused by failure to operate
the following train in accordance with
special instructions governing movements at
designated points within yard limits.

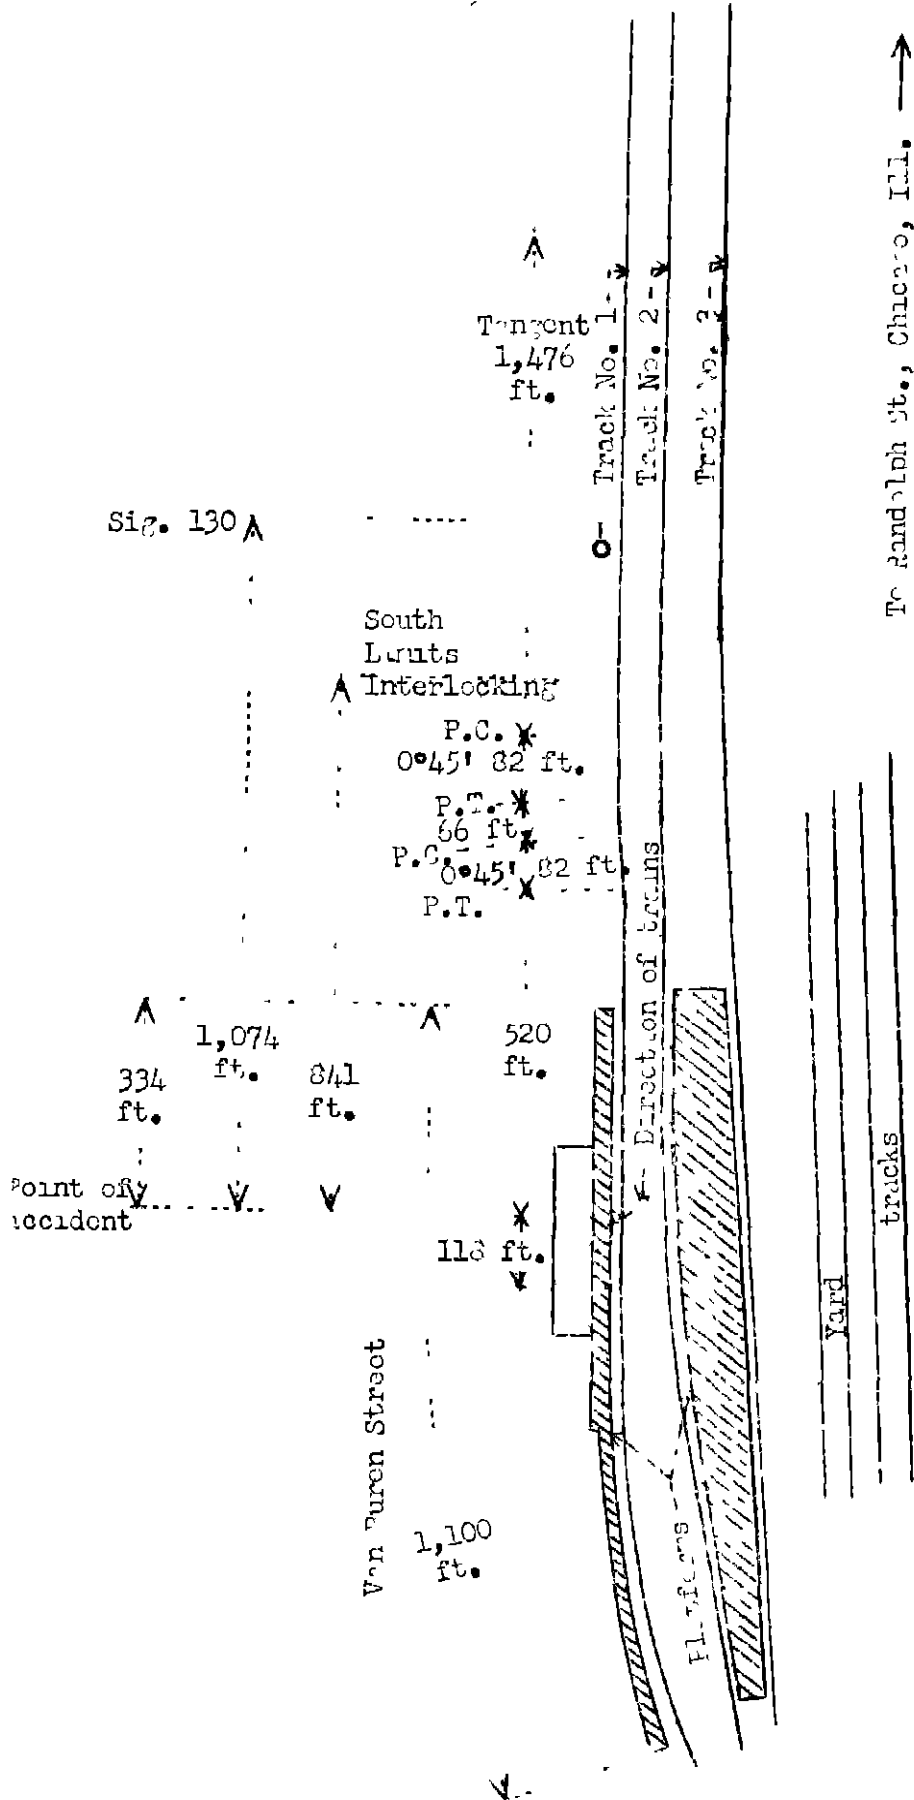
Report No. 3567
 Illinois Central Railroad
 Van Buren St., Chicago, Ill.
 April 25, 1954

• Randolph Street,
 Chicago, Ill.
 0.80 mi.
 X Van Buren Street
 Chicago, Ill.
 (Point of accident)
 13.69 mi.
 • Kensington, Ill.

To Kensington, Ill.

This accident occurred on that part of the Chicago Terminal Division extending between Randolph Street, Chicago, and Kensington, Ill., 14.49 miles. Trains of the Chicago, South Shore and South Bend Railroad regularly are operated over this portion of the Illinois Central Railroad. In the vicinity of the point of accident this is a three-track line, over which trains moving with the current of traffic are operated by timetable and operating rules. There is no block system in use in the immediate vicinity of the point of accident. A catenary system is provided for the electric propulsion of trains. From west to east the main tracks are designated as No. 1, southward, and Nos. 2 and 3, northward. Yard limits extend between Randolph Street and 11th Place, 1.15 miles south of Randolph Street, on these tracks. At Van Buren Street, 2,660 feet south of the station at Randolph Street, a platform 1,100 feet long is provided for passenger traffic on track No. 1. This platform is located on the west side of the track. A retaining wall and the station structure extend along the west side of the platform. A canopy type roof is provided. The accident occurred within yard limits on track No. 1 at a point 334 feet south of the north end of the station platform at Van Buren Street. From the north on track No. 1 there are, in succession, a tangent 1,476 feet in length, a 0°45' curve to the left 82 feet, a tangent 66 feet, a 0°45' curve to the right 82 feet, and a tangent 520 feet to the point of accident and 118 feet southward. The grade is level at the point of accident. In the vicinity of Van Buren Street, yard tracks parallel the main tracks on the east.
